## Rubber – Steel Interface Failure in Pipeline

Marek Gnatowski, Ph.D.  
Polymer Engineering Company Ltd.  
Burnaby, BC, Canada  
www.polymerengineering.ca

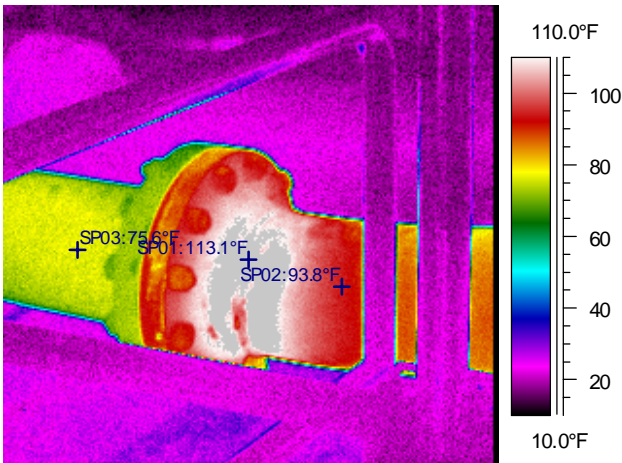
Figure 2. Thermographic picture of spool

These types of problems seemed to be detected during the investigation of the failure of a pipeline over 10 km long in a North American plant. The pipeline, which is 200 mm in diameter, was constructed from 12.5 meter long spools lined inside with 6 mm thick natural rubber compound. The materials and process used in pipeline manufacturing could be accepted as industrial standards. An infrared inspection of the pipeline conducted by the plant after 5 years of service at a temperature of approximately 50°C showed a significant temperature increase in numerous areas of the pipe surface (figure 2) which was likely related to liner failure. Furthermore, inspection of the individual spools revealed a large number of blisters, rubber breakdown, and adhesion failure between the rubber and steel (figure 3). A segment of spool with characteristic blisters was sent to Polymer Engineering Company Ltd. for further laboratory evaluation.

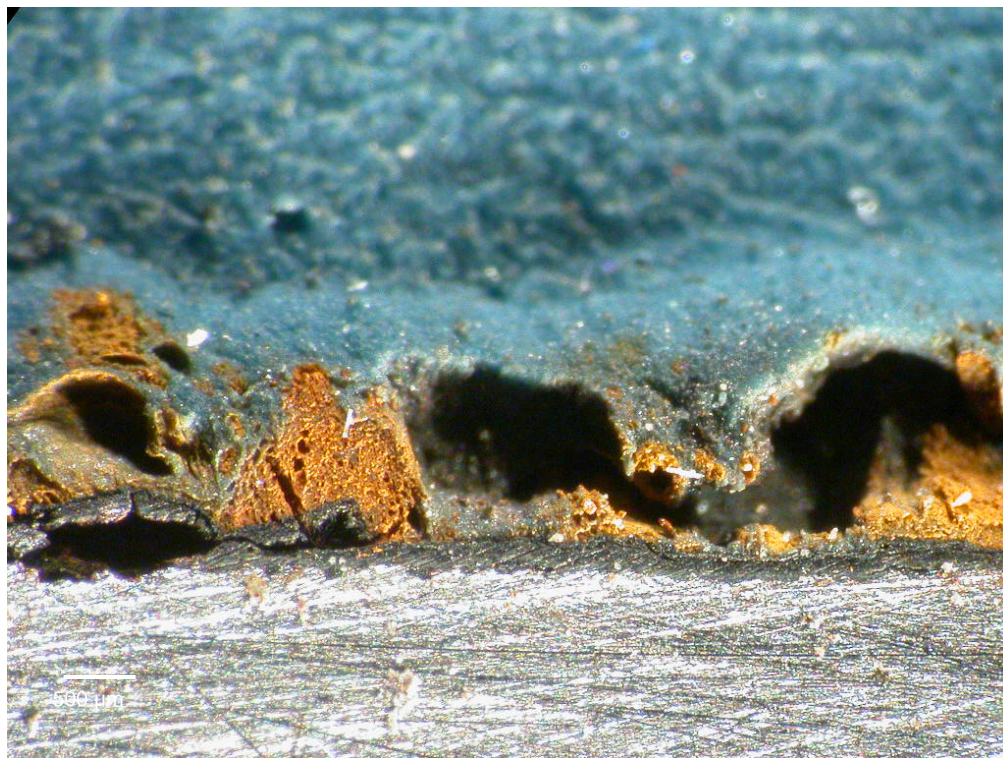
Figure 4

The optical microscopy revealed that the rubber in the vicinity of the interface showed significant porosity with a spongy appearance in many places that were in contact with the adhesive layer. Voids in the foamy structure were filled with a brownish substance – likely precipitated iron oxides. There were many small pinholes and signs of blisters in the adhesives layer with eroded metal cavities underneath that are likely associated with corrosion. In particular, the cross-section visible in figure 4 shows that some regions of the steel/rubber interface are full of microfoam-like cavities in the rubber. Some of the cavities are filled with porous brownish iron oxide deposits. A significant portion of the adhesive system film seems to be intact except for some damage caused by corrosion where the primer is lifted from the steel and the cavity was eroded beneath by the electrochemical corrosion process. The iron extracted from the steel seems to be transferred by diffusion to the rubber and rubber cavities, and some further precipitated in the form of oxides.

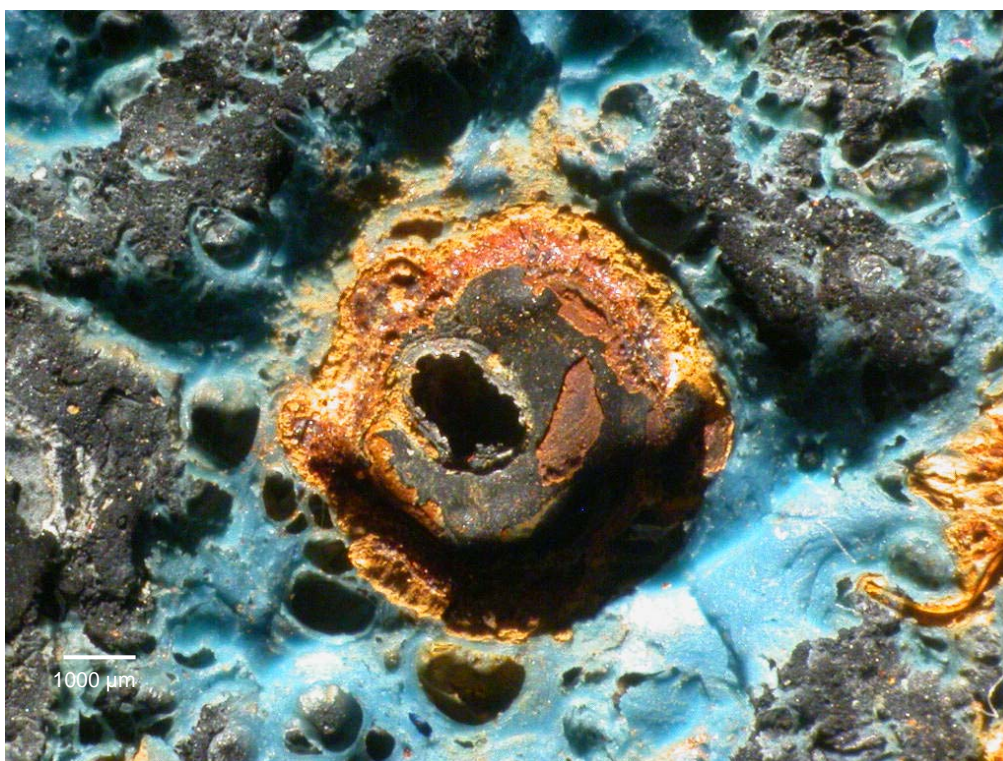
Figure 5

Another look at the surface of the steel/rubber interface is shown in figure 5. The blue rubber remains and black adhesive surfaces are visible with some exposed gray or rusty metal surface. Failure of the interface occurred approximately 50% within the rubber, and 30% between the adhesive and rubber. Also, some failure is seen between the metal and adhesive layer in the examined area. In the centre, a blister and entry to a large cavity in the steel is visible with some rusty steel exposed where the protective coating is missing, likely in a cathodic disbondment process known in coatings. It could be expected that the blister was initiated by a coating defect.

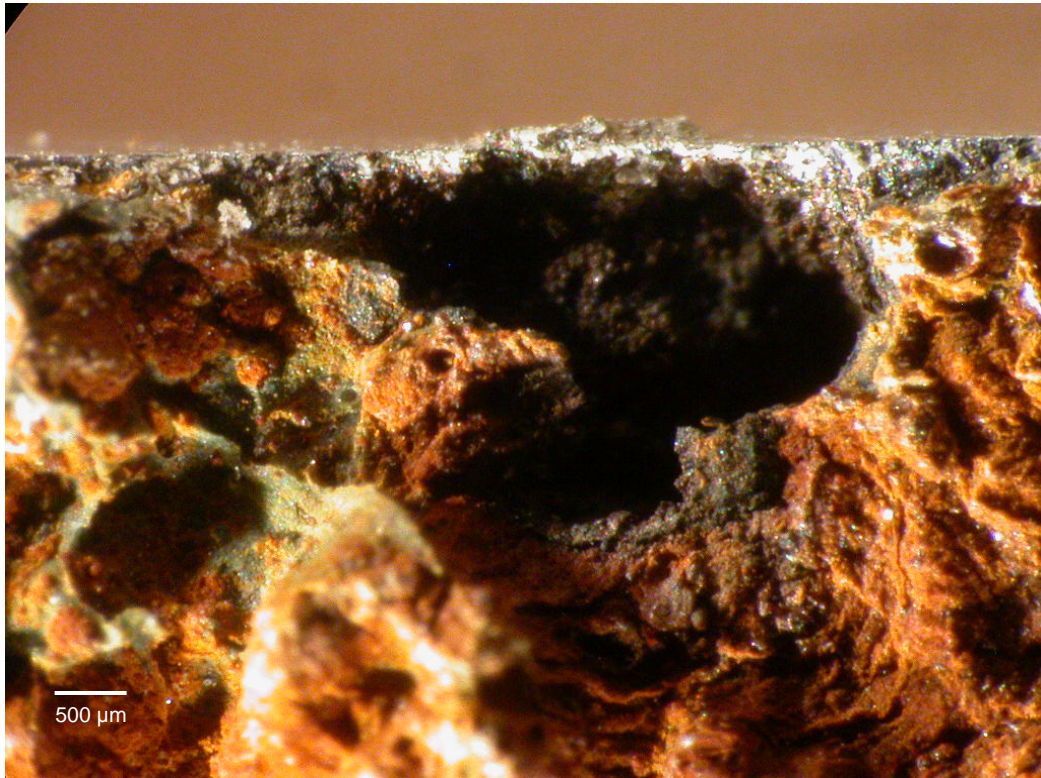
Figure 6.

Optical microscopy of the rubber-steel interface is shown in figures 4, 5, 6, and 7. Specimens were specially prepared to obtain an intense blue colour in the rubber. The excess of hydrated iron oxides from the surface were also removed from some samples by selective etching.

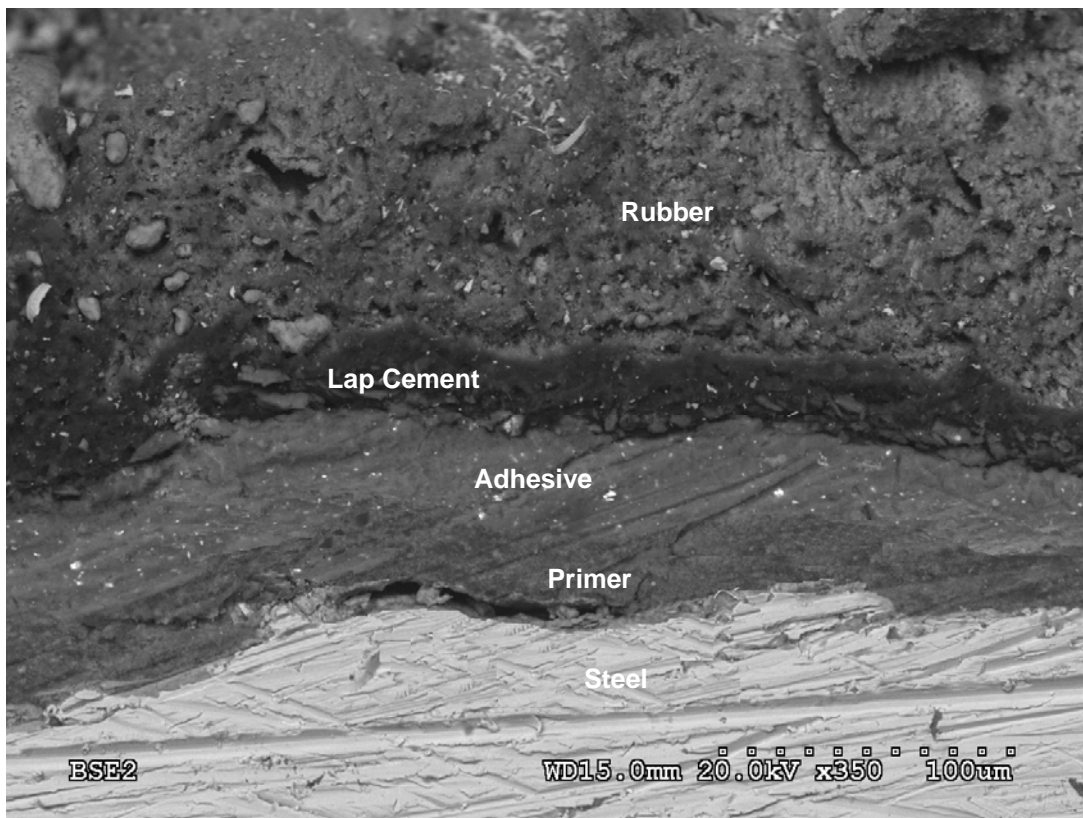
Electron microscopy, including EDX analysis, indicated the presence of large quantities of chlorine in the primer and adhesive. Titanium was present only in the primer as identified on the SEM images and the presence of bromide was characteristic only to the adhesive used.

Figure 8. SEM image of steel-rubber interface

The difference in the density of material layers allowed different components of the interface to be distinguished and thickness to be estimated. The thickness of all coatings was found to be according to industry standard and close to the manufacturers recommendation. EDX examination also showed the presence of manganese in the steel, which was likely the source of manganese ions in the blister water.

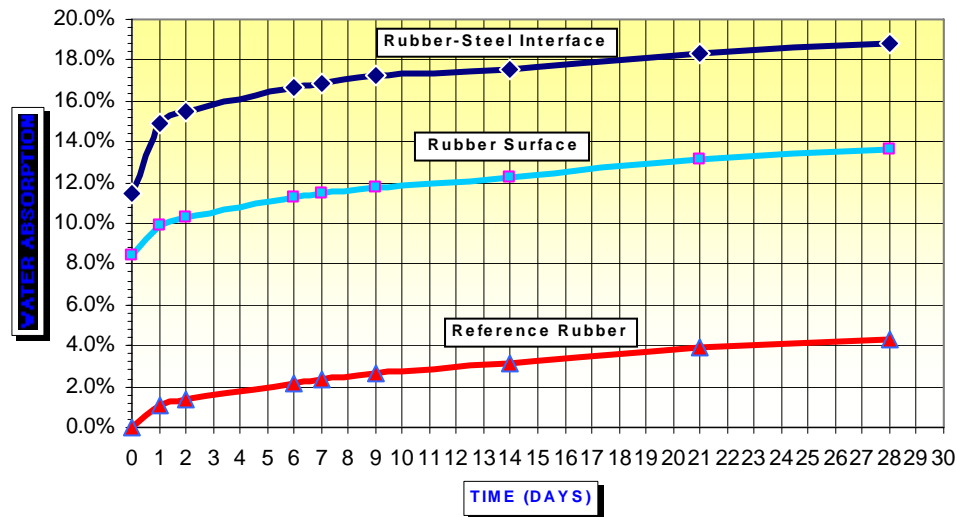
Figure 9. Water absorption of failed liner rubber

It has to be noted that the failed rubber liner had relatively high initial water absorption of approximately 12% near the interface and 8% near the surface several weeks after removal of the spool from service. After immersion in water at 23°C, water absorption of the samples increased rapidly during the first day of immersion (to approximately 15% for the interface and 10% for the surface specimens). From this point, both samples followed the water absorption of the natural rubber reference sample. After 30 days of immersion, the interface specimens absorbed almost 20% water.

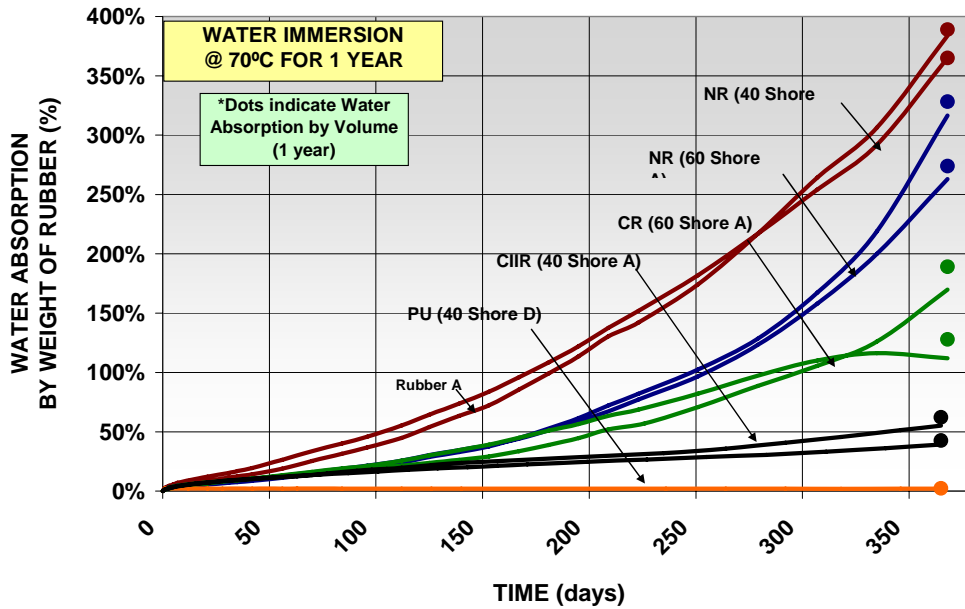
The results clearly indicated that, at certain service conditions, rubbers may absorb very significant quantities of water reaching almost 400% by weight. The water absorption rate seems to increase with exposure time and exposure temperature. These rubber properties should be taken under serious consideration when an adhesive system is designed for an application with possible prolonged contact with water. This water absorption, in combination with the so called "cold wall effect" which may occur at some service conditions will also cause liquid water condensation and accumulation near the steel rubber surface which may lead to accelerated corrosion and bond failure. This issue seems to not always be addressed during development of adhesive systems, material testing procedures, or material selection.

Figure 10. Water absorption of selected rubbers
