Magnetic resonance imaging used for the evaluation of water presence in wood plastic composite boards exposed to exterior conditions

MAREK GNATOWSKI¹, REBECCA IBACH², MATHEW LEUNG¹, & GRACE SUN¹

¹Polymer Engineering Company, Burnaby, BC, Canada and ²USDA Forest Service Forest Products Laboratory, Madison, WI, USA

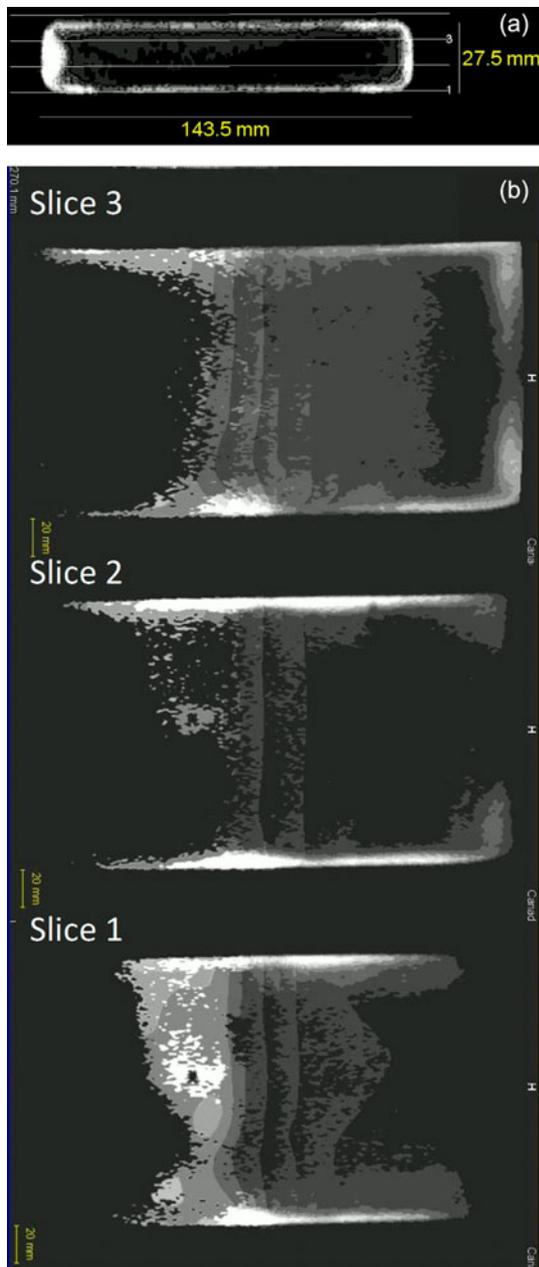
Figures 10 to 12 show sharp bright borders along the board edges where the majority of the absorbed free water was present. The measurements, based on the external bright border of the sample, taken from Figure 10a confirmed the physical size of the board dimensions with good accuracy. The board width and thickness measured by MRI image analysis on Figure 10a was 143.5 mm (5.65") and thickness 27.5 mm (1.08"), respectively, while the width and thickness of the exposed, wet board measured directly with a calliper was 143.3 mm (5.67") and 27.5 mm (1.10"), respectively. A similar bright border which indicated the presence of free water above wood fibre saturation can be seen in the images obtained in Plane 2 Slice 8 taken in the middle between the exposed end and the support (Figure 11b).

Figure 10. MR images of experimental WPC board #106 obtained in Plane 1 with (a) slice locator and (b) selected Slices 1, 2 and 3 in this plane (horizontal). Note the board dimension measurements obtained using the MRI software measuring tool.

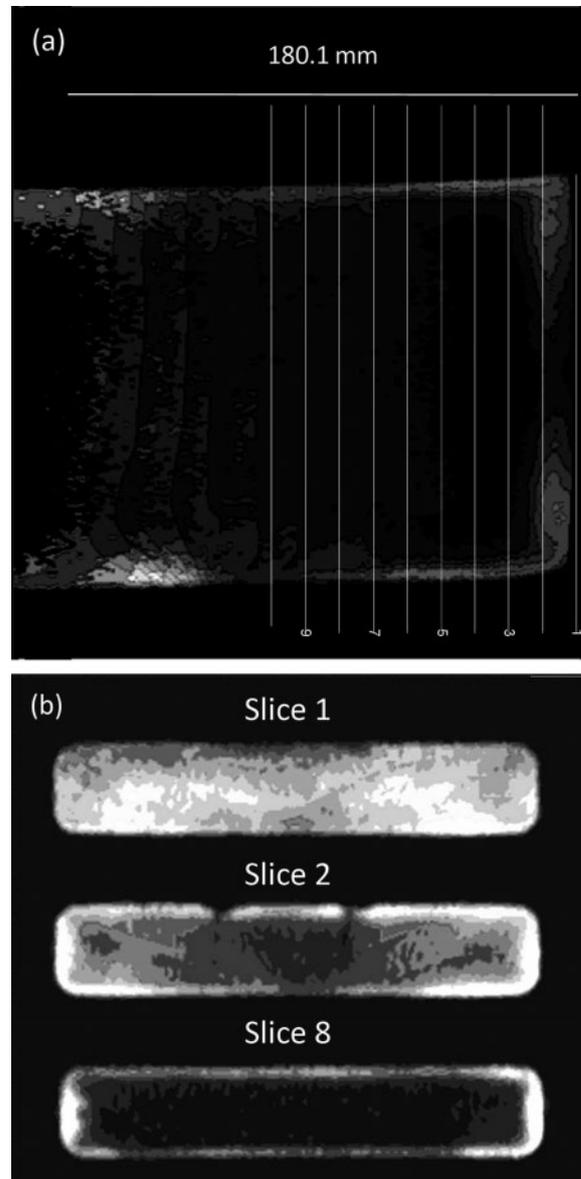
Figure 11. MR images of experimental WPC board #106 obtained in Plane 2 with (a) slice locator and (b) selected Slices 1, 2 and 8 in this plane (perpendicular to the board length direction).

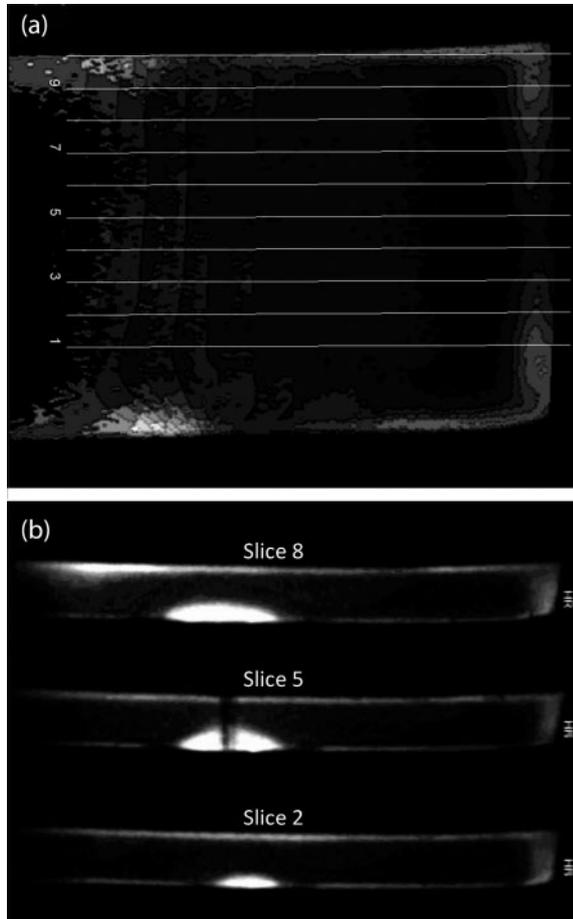
The sides of the board were another place that was identified as being sensitive to water entry in the composite. The cut end was particularly sensitive to moisture absorption (Figure 13b). Here, the MC zone that exceeded the fibre saturation point in wood ranged about 15 mm, regardless of the fact that this end was freely suspended in the air without the presence of factors that may have contributed to increased water uptake. Some explanation of this phenomenon could be the wood fibre orientation associated with the extrusion process and the expected preferred direction of moisture migration along these fibres.

Figure 12. MR images of experimental WPC board #106 obtained in Plane 3 with (a) slice locator and (b) selected Slices 2, 5 and 8 in this plane (parallel to the board length direction).

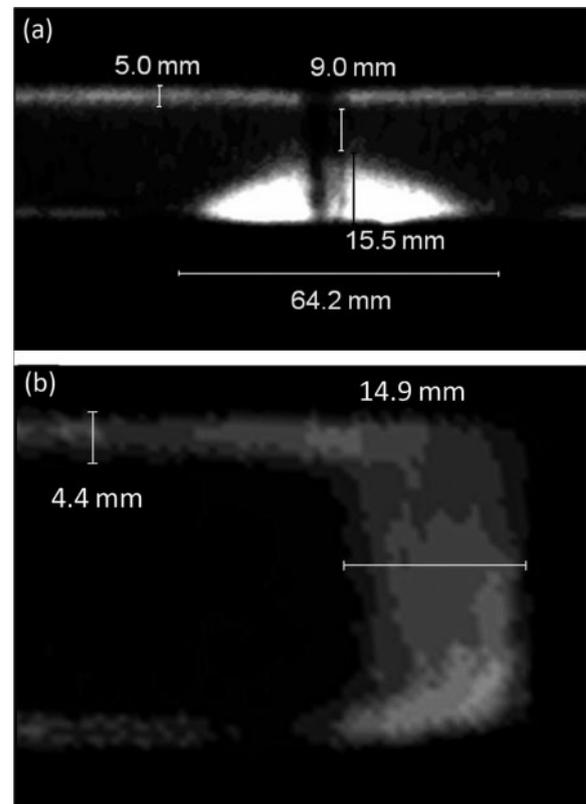
Separate attention was required for the MR images in the area of the board support that had a significantly larger bright area which propagated towards the board centre, as well as for the exposed end of the board, which also showed increased WA in the form of a bright pronounced area. As shown in Figures 12 and 13a, the board support area seemed to be the largest factor in water entry for the WPC decking. The zone with MC around 25% and above in this area penetrated to about 15.5 mm (0.61") from the board bottom surface in a semi-elliptical shape. This maximum, as expected, was in the middle of the 38 mm wide support. It is also interesting that the zone with increased MC was not only limited to direct contact of the board with the support but also significantly extended to span over 64 mm (2.52"). The MR image also indicated that only 9 mm (0.35"), which was about 35% of the board cross-section in this area, had MC below the fibre saturation point. Due to the shape of the moisture distribution, very limited information with respect to the range of moisture increase of the WPC board in contact with the support could be obtained from destructive testing. This increase of MC in the WPC board in the area of the support could be easily explained by the mass transfer phenomenon associated with limited water drying in this area, combined with the easy entry of water along the WPC board and the support interface. This phenomenon

also occurs frequently in solid wood structures, causing significant decay damage. Also of interest was a visible dark shadow in the centre of the board in Figure 13a which matched the location of a hole drilled in this place for a fastening screw. No significant increase of MC around this location during exterior exposure was detected. Only some limited increase in MC, in the form of a brighter spot on the side of the darker shadow that is the image of the empty screw hole, can be seen in the MR image. This brighter spot could also be

Figure 13. (a) Magnified area of the board support visible in Plane 3 Slice 5 with measurements indicating water presence above wood fibre saturation and (b) magnified area of cut end of the board visible in Plane 3 Slice 2 with measurements indicating water presence above wood fibre saturation.

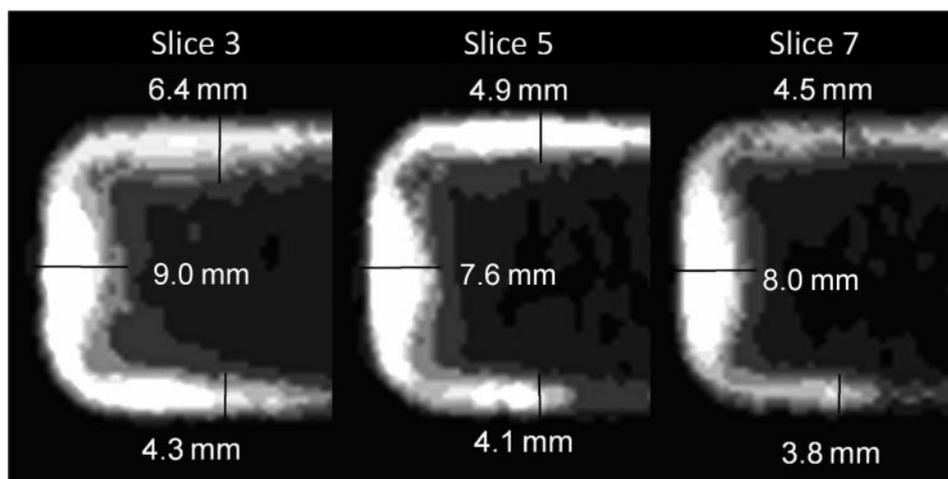
board thickness to about 10 mm (0.39") as shown in Figure 14. This water distribution pattern could not be fully explained at this point and may be related to the composite porosity present in this region due to extrusion stresses or other related conditions.

Figure 14. Magnified MR images of Plane 2 selected Slices 3, 5 and 7 from the side of the experimental WPC board #106 with measurements indicating the depth penetration of water above wood fibre saturation.

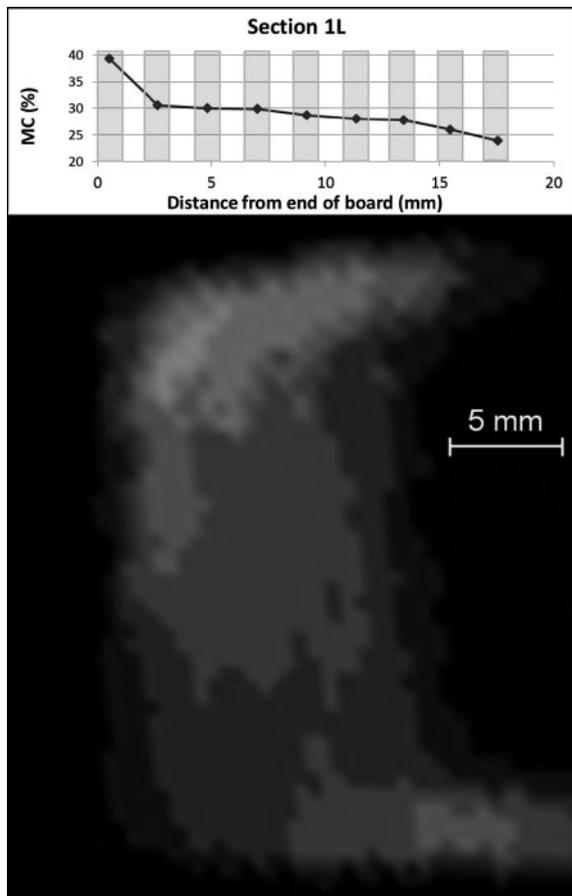
As shown in Figures 15–17, the bright part of the image became grey and began to disappear, matching the black background around the point where the MC in wood reached 22–24%. This is particularly visible in Figure 16 and part of Figure 17, where water diffusion occurs in only one direction, along the vertical plane. This indicated that the moisture saturation point was most likely reduced in the

Figure 15. MC of wood found in the experimental board cross-section 1L around the cut edge with distance from the board end in comparison to an MR image of this area (Plane 3 Slice 2). The shaded areas on the graph indicate the location and thickness of individual wafers used for destructive MC testing.

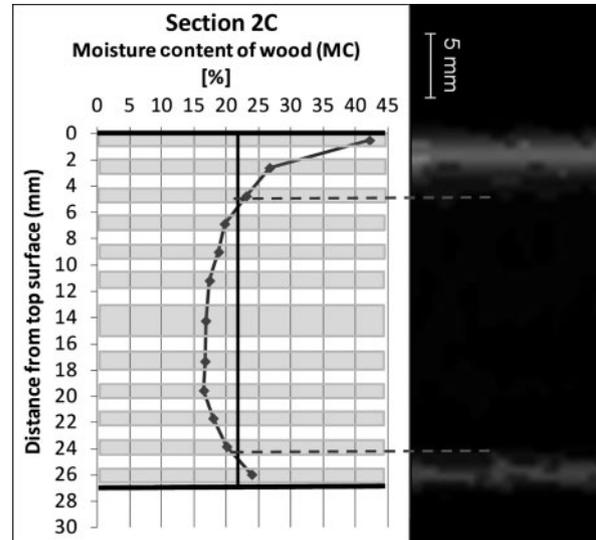
Figure 16. MC of wood found in the experimental board cross-section 2C with distance from the exposed board surface in comparison to an MR image of this area (Plane 3 Slice 5). Approximately 22% MC, which is around the wood fibre saturation point, is marked on the graph. The shaded areas on the graph indicate the location and thickness of individual wafers used for destructive MC testing.

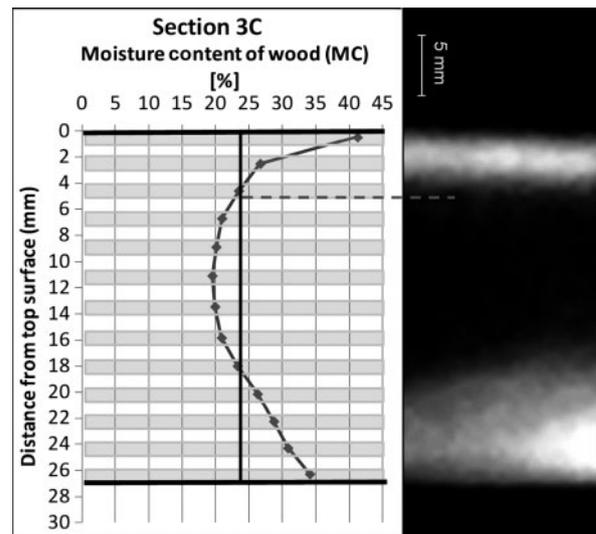
Figure 17. MC of wood in section 3C at board support with distance from the exposed board surface in comparison to an MR image of this area (Plane 3 Slice 5). Approximately 24% MC, which is around the wood fibre saturation point, is marked on the graph. The shaded areas on the graph indicate the location and thickness of individual wafers used for destructive MC testing.

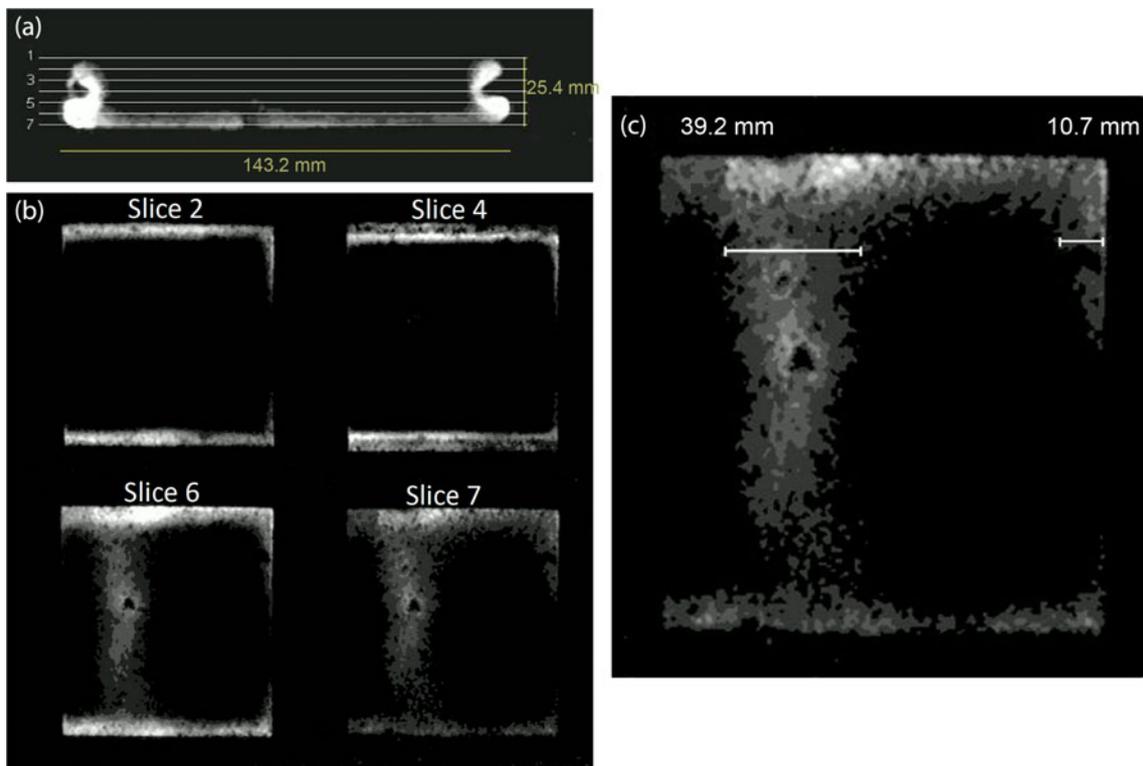
The pattern of water entry in the commercial WPC board imaged after exposure near Hilo, Hawaii, for 2 years (Figures 18–21) was similar to that found earlier in experimental composite board #106. The exception was the upper board surface, where no brighter image associated with presence of water was detected. This surface was covered by a coextruded polyethylene coating (capping), which seemed to be very effective in protecting the WPC board body against moisture entry into the upper board surface. The location of this protective coating, not always well visible on the MR images, has been marked with a dashed line. There were, however, signs of significant vulnerability of this board to water entry at other places. At the support area, MC above the fibre saturation point in wood measured almost 7 mm (0.28") in comparison to only up to 2 mm (0.08") along the lower surface as shown in Figure 21a and b, respectively, despite only 2 years of exterior exposure for this sample.

Figure 18. MR images of the commercial WPC board obtained in Plane 1 with (a) slice locator, (b) selected Slices 2, 4, 6 and 7 in this plane (horizontal) and (c) magnification of Slice 6 with measurements indicating water presence above wood fibre saturation.

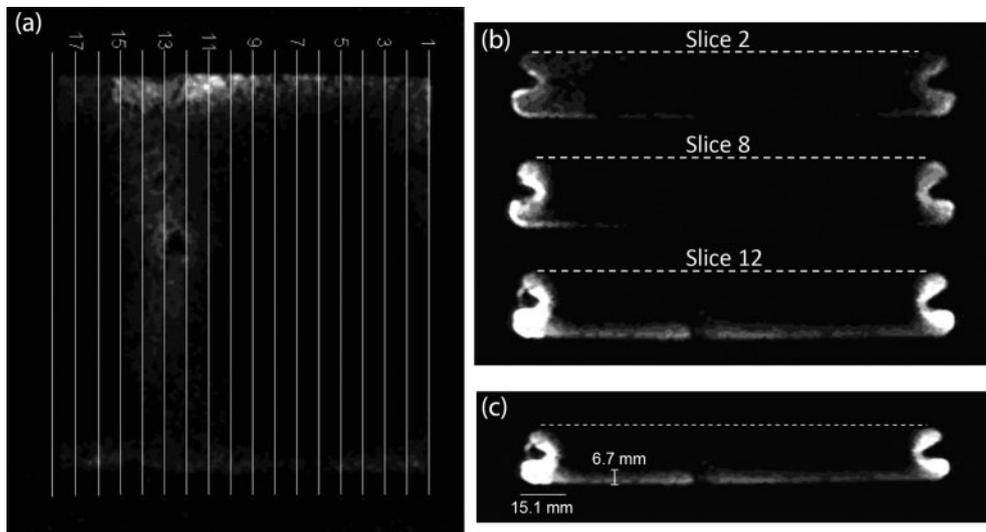
Figure 19. MR images of the commercial WPC board obtained in Plane 2 with (a) slice locator, (b) selected Slices 2, 8 and 12 in this plane (perpendicular to the board length) and (c) magnification of Slice 12 with measurements indicating water presence above wood fibre saturation. The dotted lines in (b) mark the edges of the board protected by the extruded coating.

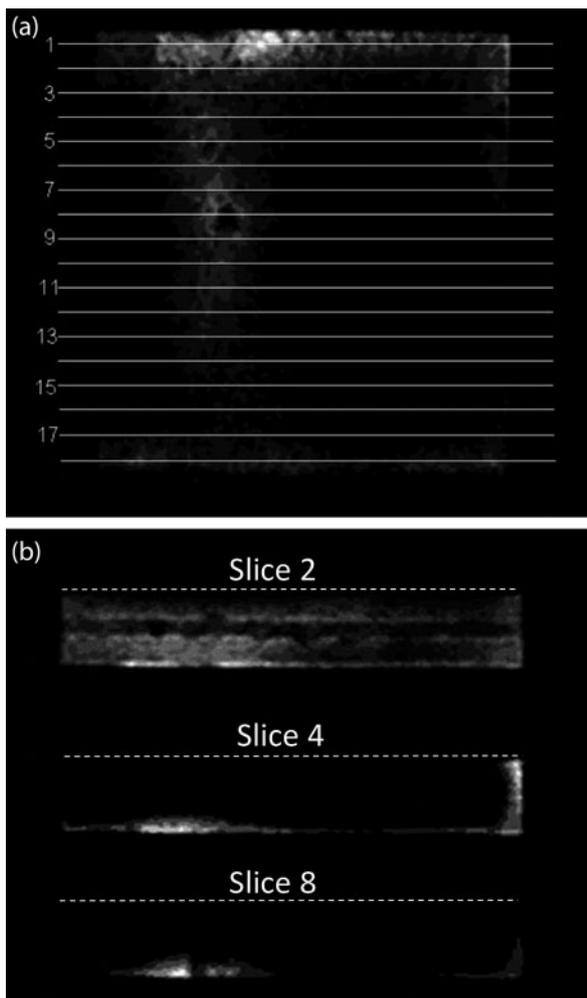
Figure 20. MR images of commercial WPC board obtained in Plane 3 with (a) slice locator and (b) selected Slices 2, 4 and 8 in this plane (vertical and parallel to the board length). The dotted lines in (b) mark the edges of the board protected by coating.

Furthermore, there was a large water entry area associated with the board's fastening grooves with accumulation of free water from the exposed side up to a distance of about 15 mm (0.59"). This aggressive water entry could be seen extending into the area covered by the coextruded coating as shown in [Figure 19](#). Partial entry of water under the coextruded coating may have created an accumulation of water in this area due to the reduced possibility of evaporation. This WA around the grooves was present all along the tested board segment.

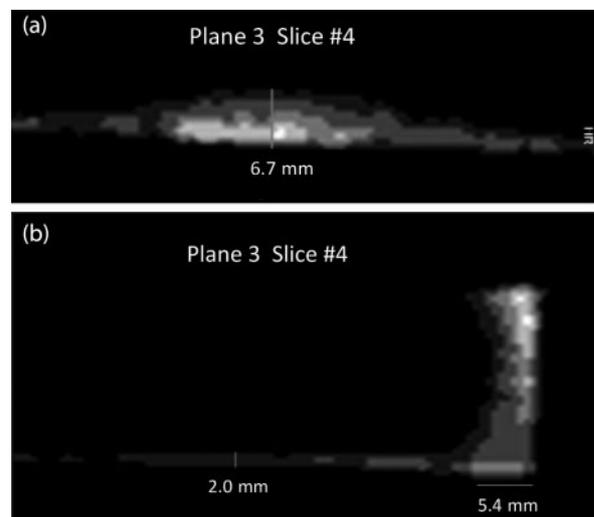
Figure 21. Magnification of an MR image of the commercial WPC board in (a) Plane 3, Slice 4 in the area of the board support and (b) Plane 3 Slice 4 in the area of the board cut end, both with measurements indicating water presence above fibre saturation point.

As could be expected, there was also significant WA at the cut end of the board as shown in Figure 21b. The penetration depth of excessive MC above the wood fibre saturation point was variable along the surface, with a large region around board edges assessed at about 6 mm (0.24"). Note that this end of the board was cut 1 year earlier for another purpose, prior to the tested sample collection. The cut end of the board and the support area together with the grooved board seemed to be the most vulnerable water point of entry as identified by MRI. It would be very difficult to protect this area, and additional accumulation near the edges may occur due to evaporation being obstructed by the coating.
