# Rubber-Steel Interface Failure in Pipeline

Marek Gnatowski, Ph.D., Eng.  
Polymer Engineering Company Ltd.

# Pipeline Failure

- Over 10 km long
- 200 mm (6") ID
- 12.5 m (40') long spools
- 6 mm (1/4") natural rubber liner

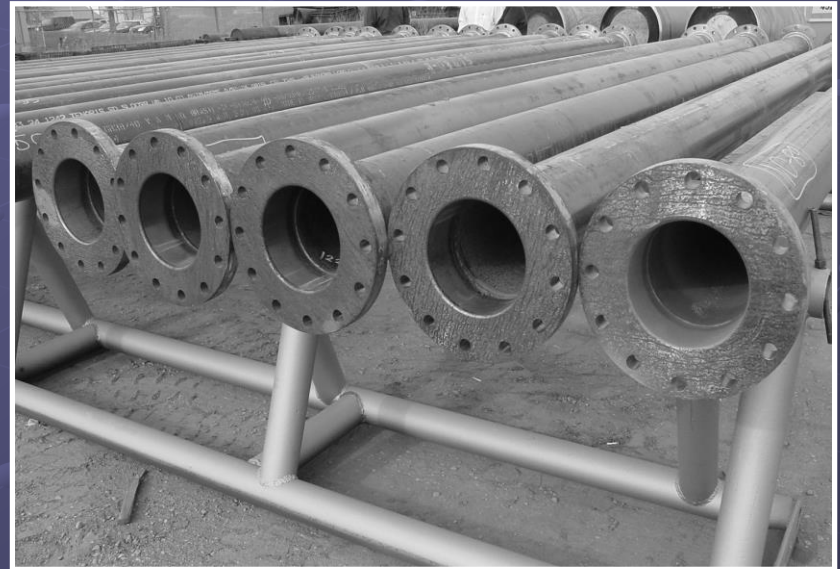
- Exposed to exterior environment
- Transporting gypsum slurry
- Slurry temperature approximately 50°C (122°F)

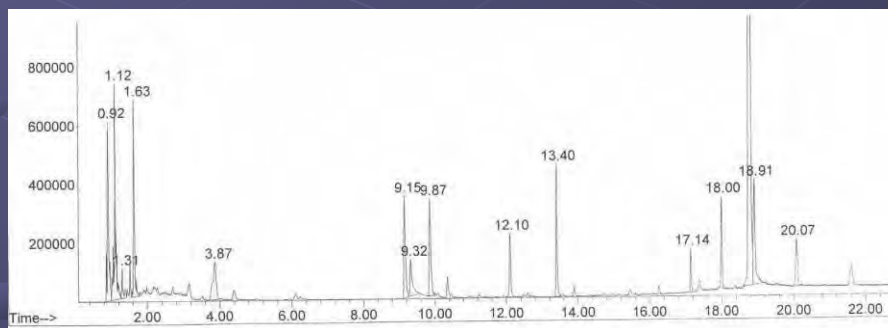
Acetic and Formic Acids as gaseous components released from liner rubber

Compound	Ret. time min	Concentration $\mu\text{g/g}$	
		Surface	Interface
Acetic acid	9.14 – 9.23	102	1392
Formic acid	9.86 – 9.96	80	1845

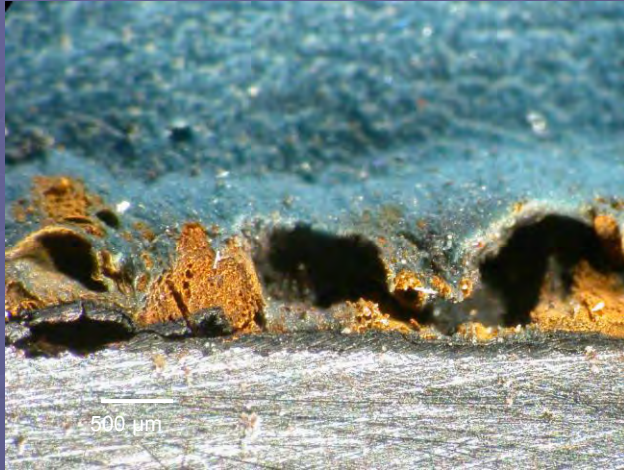
cross-section

## Microscopic pictures of rubber steel interface

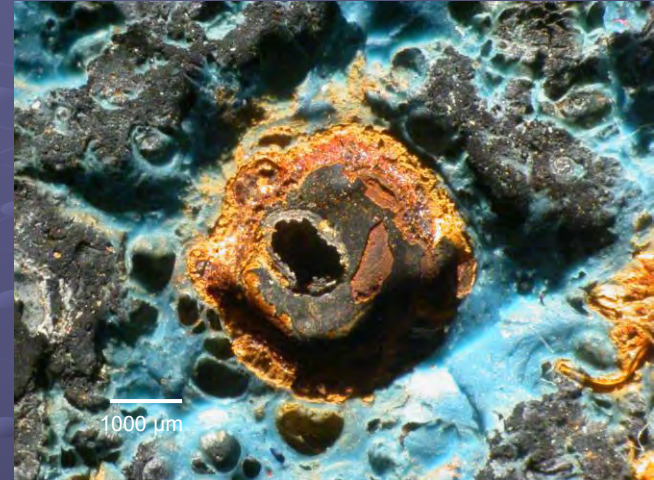
delaminated surface

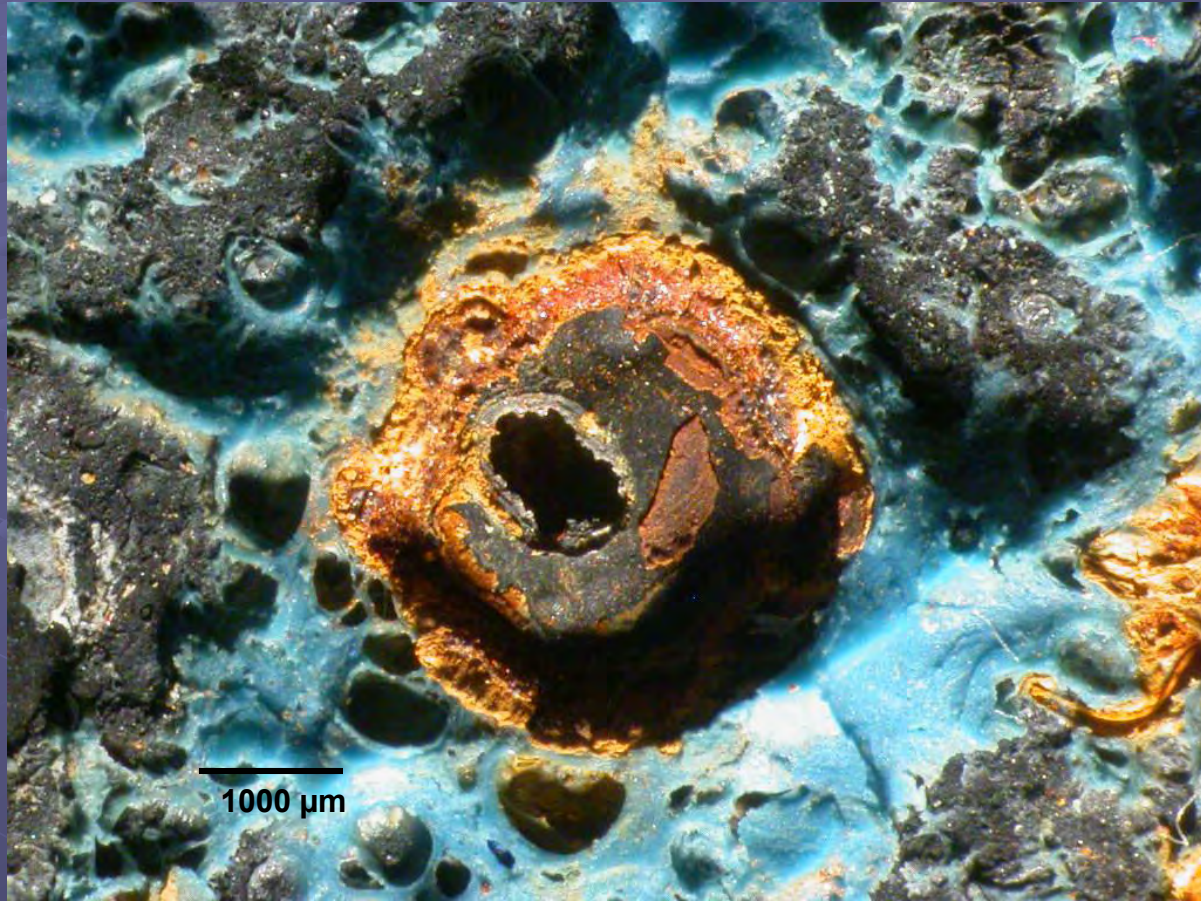
delaminated surface

Microscopic pictures of rubber steel interface
